Atlantic Richfield Company

April 18, 2017

RE: Leviathan Mine Site: Update on Limited Access Season Site Conditions
April 5 - 12, 2017

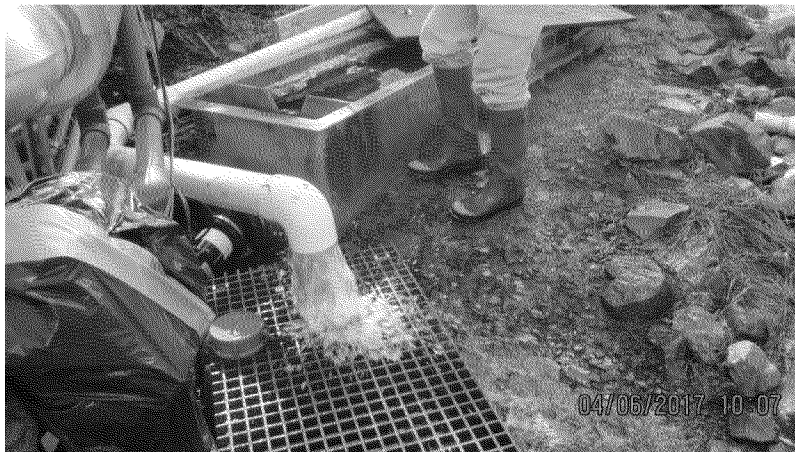
On April 6, 2017, at approximately 3:30 PM PDT, Atlantic Richfield received word from the LRWQCB that a connection on the overflow riser pipe assembly in Pond 4 (near the HDS

treatment building) had separated a few inches below the water line, and as a result, water was discharging through the overflow pipe to Leviathan Creek. Photographs sent by the LRWQCB are shown below:

It appeared from the photos that the separation may have resulted from ice pushing against the riser pipe assembly. Atlantic Richfield does not normally have personnel at the site at this time of year, and the pipe separation was not the result of any human-caused activity. It also appeared that there were only a few inches of standing water in Pond 4 above the pipe separation, and the section of pipe below the separation was intact. According to Doug Carey, LRWQCB Board crews who were at the site earlier in the week did not observe any discharge from the Pond 4 overflow pipe, so we assume the separation occurred sometime between April 4 and April 6, 2017. pH measurements from EPA's data sonde in Leviathan Creek at 4L did not suggest that the resulting discharge from Pond 4 was having any significant effect on surface water quality during this time:

On April 7, 2017, Copper Environmental field personnel entered the site, despite poor weather conditions (sleet and snow). Personnel waded into Pond 4 and re-set the overflow pipe riser assembly into the lower pipe receiver as best they could. Personnel also placed temporary sandbags around the pipe riser assembly in an attempt to stabilize the piping. Discharge from Pond 4 through the discharge pipe increased briefly while the pipe riser assembly was being removed and then reset. After resetting the assembly, the discharge rate decreased, but flow was not completely stopped. As a result, Copper began formulating plans for additional, more permanent repairs to the pipe riser assembly to be made the following week.

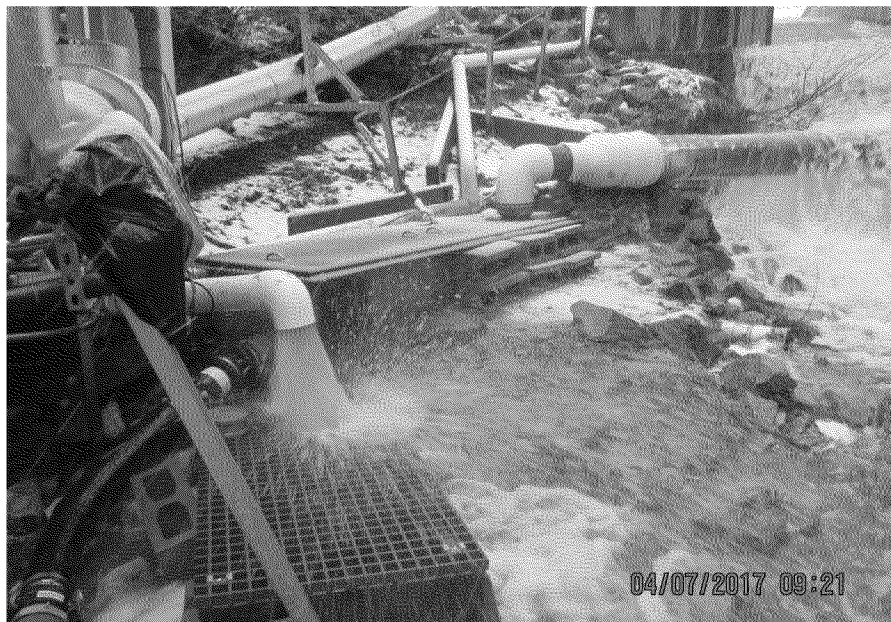
April 7, 2017: Overflow pipe discharge while Pond 4 pipe riser assembly was being removed and re-set.
